METHODS FOR LOCATING POOL LINER LEAKAGE AT NUCLEAR POWER PLANTS

REPORT 2026:1156

**A Review and Experimental Evaluation of Inspection
Techniques for Underwater and Robotic Deployment**

MARKUS NILSSON

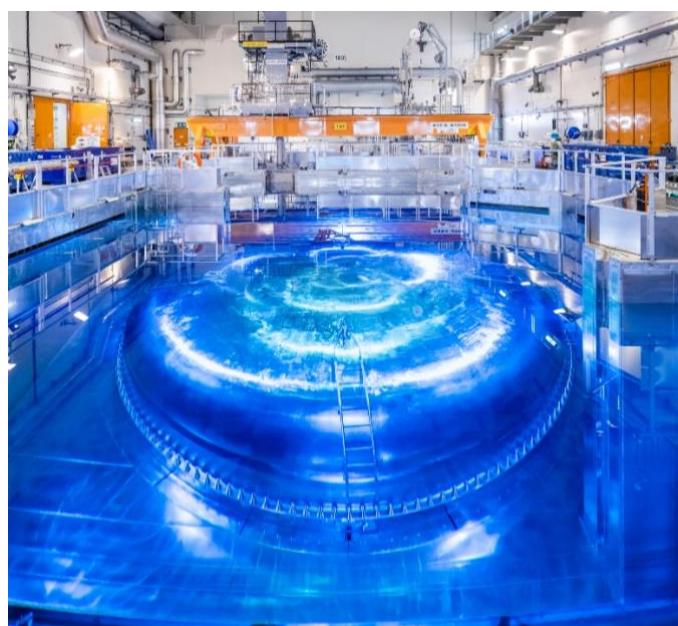
Figure 1. Reactor basin in a BWR plant, Oskarshamn 3. Source: OKG AB.

In Pressurized Water Reactors (PWRs), water is kept under high pressure to prevent boiling as it circulates through the reactor core. The heat from the reactor is transferred to a secondary loop, where steam is generated to drive a turbine and produce electricity. Boiling Water Reactors (BWRs), on the other hand, allow water to boil directly in the reactor core, generating steam that is sent directly to the turbine. A reactor basin in a BWR plant is shown in Figure 1, illustrating the pool environment nuclear power plants (image courtesy of OKG AB).

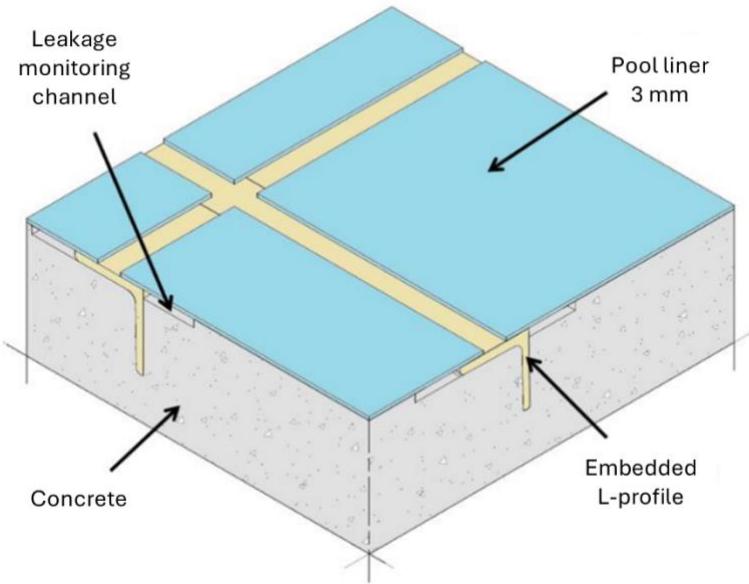
Figure 2. Illustration of the pool liner and related components.

Dissimilar metal welds, which are used to join austenitic stainless steels to other materials, such as the L-profiles illustrated in Figure 2, introduce additional complications. These welds often feature abrupt changes in microstructure and mechanical properties across the interface, increasing the likelihood of residual stress concentrations, localized corrosion, and crack initiation.

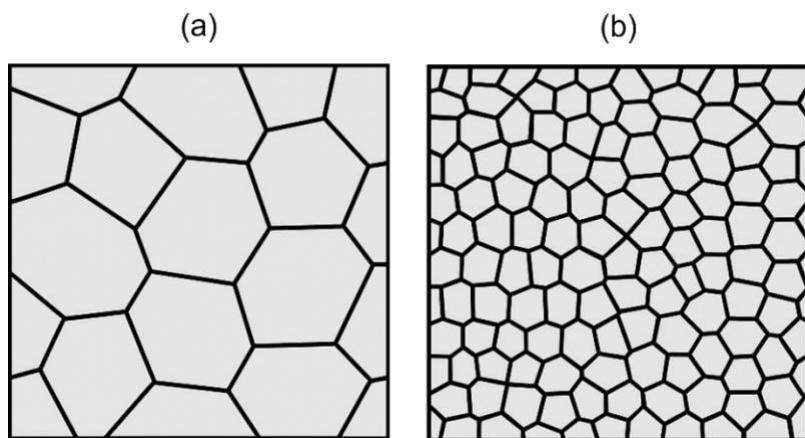
Figure 3. Grain structure for (a) austenitic steel and (b) ferritic steel.

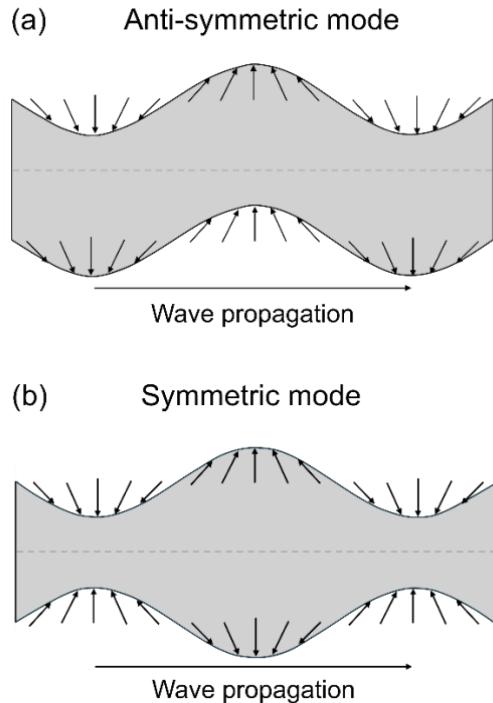
Figure 4. Illustration of guided Lamb wave modes in a plate. (a) Anti-symmetric mode and (b) symmetric mode. The dashed line indicates plate center.

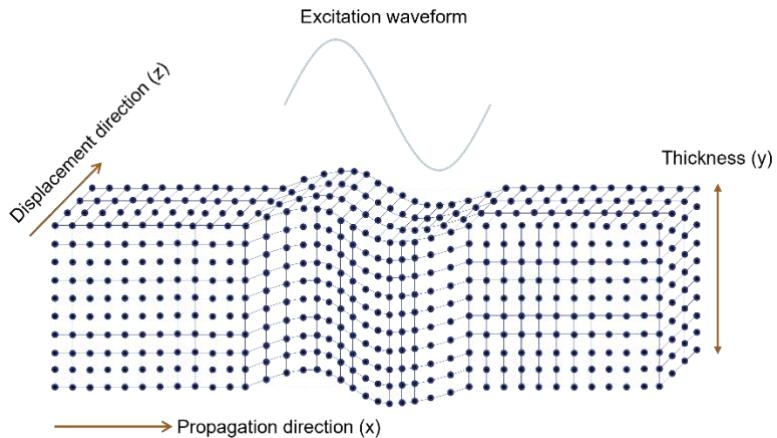
Figure 5. Illustration of a horizontally polarized shear wave with unidirectional displacement in the z-direction and propagation in the x-direction. No excitation is applied in the y-direction. Figure reproduced from [15].

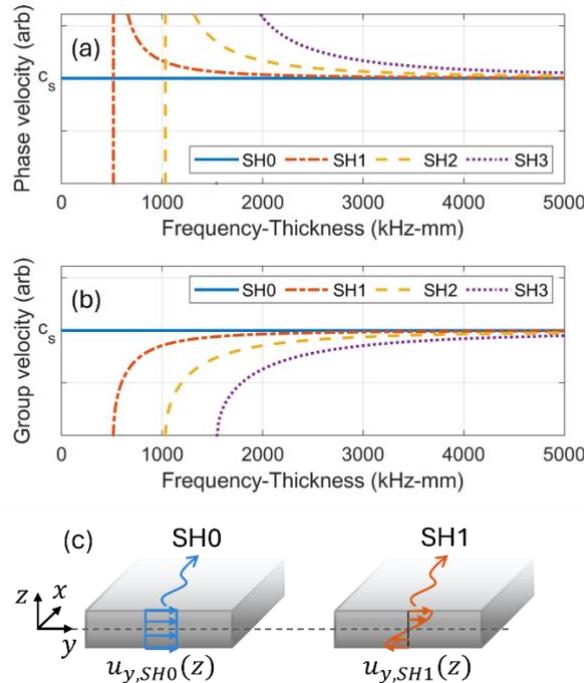
Figure 6. Dispersion curves for shear-horizontal (SH) guided waves in a 3 mm stainless-steel plate. (a) Phase velocity and (b) group velocity as functions of frequency–thickness. (c) Corresponding through-thickness displacement (mode) shapes $u_y(z)$ for SH0 and SH1.

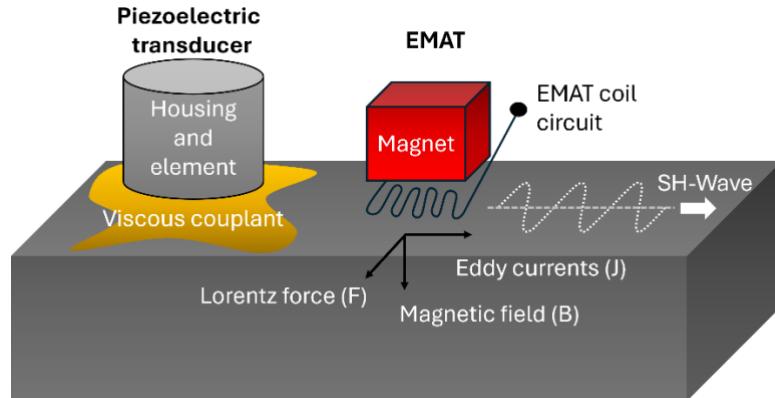
Figure 7. Illustration of a standard piezoelectric transducer compared to an EMAT.

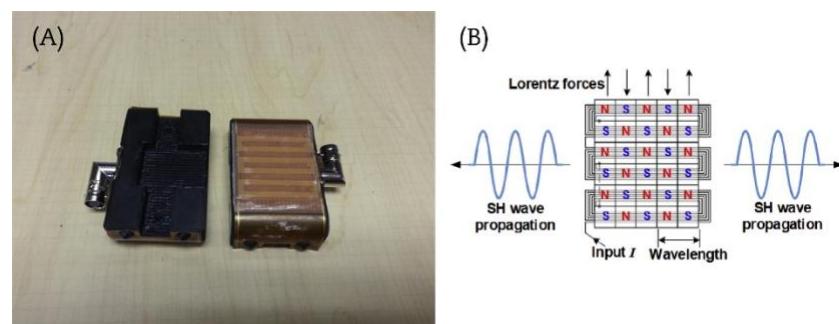
Figure 8. Electromagnetic acoustic transducers (EMATs) to send and receive shear-horizontal (SH) waves. (A) Pair of compact periodic permanent magnet EMATs. (B) Schematic diagram of the SH wave generation mechanism by Lorentz forces. Adapted from Choi et al. [22], licensed under CC BY-NC-ND 4.0.

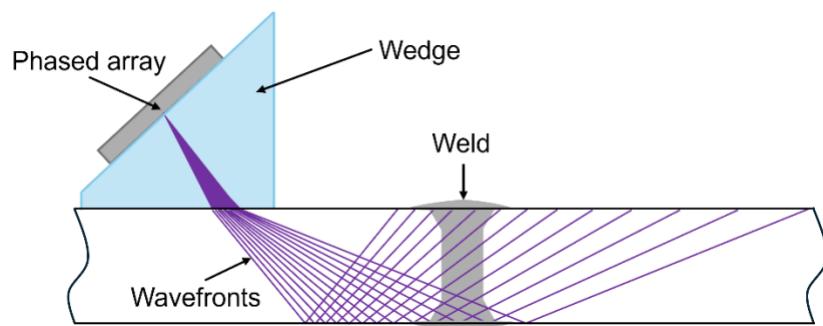
Figure 9. Illustration of phased array ultrasonic testing (PAUT) showing beam steering and focusing capabilities for weld inspection. By electronically controlling the delay patterns across multiple transducer elements, the acoustic beam can be swept through a range of angles and depths to enhance defect detection.

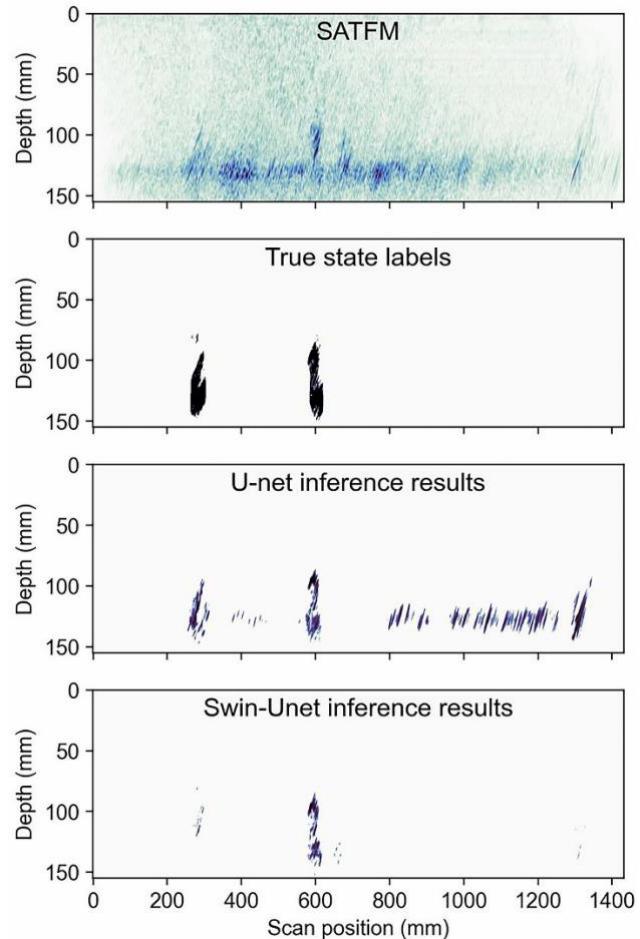
Figure 10. PAUT imaging using combined SAFT and TFM (SATFM). The top plot shows the reconstructed image as viewed by the inspector, while the second plot presents the ground-truth flaw positions. The two lower images show results obtained using two different neural network architectures (U-Net and Swin-U-Net), illustrating differences in predicted flaw locations. Reproduced from Sorger et al. [33], licence under CC BY 4.0.

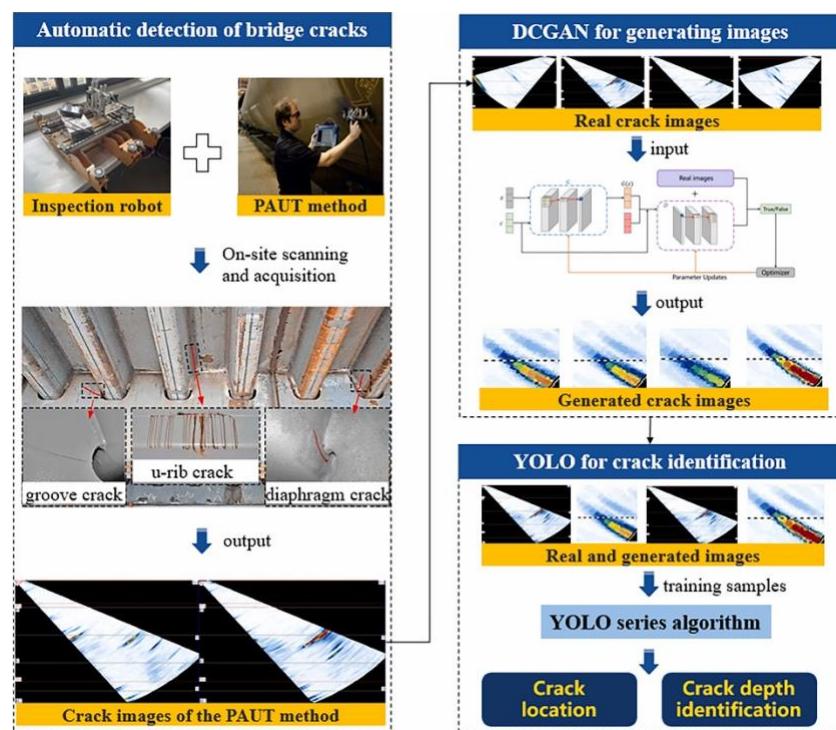
Figure 11. Automated PAUT inspection framework integrating robotic scanning and deep learning-based flaw evaluation as suggested by Zhang et al. [35], licensed under CC BY 4.0.

images and You Only Look Once (YOLO) crack identification algorithm, is shown in Figure 11.

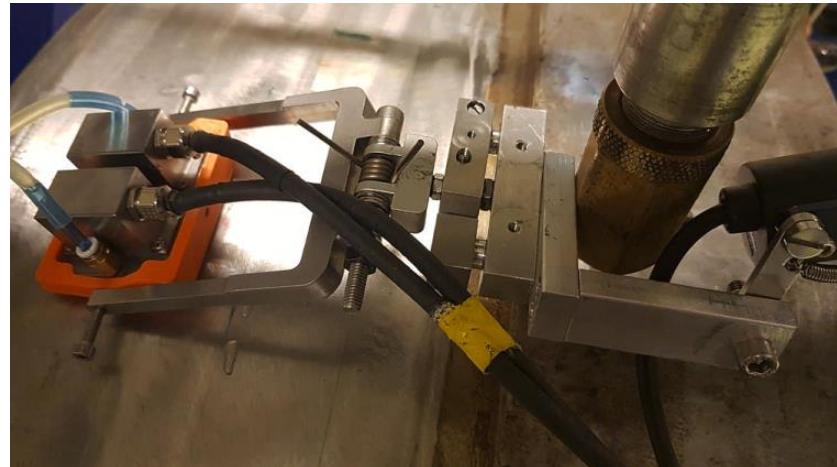
Figure 12. Scan setup for dissimilar weld mock-up. Adapted from Virkkunen et al. [32]. Observe the water-feed to the transducers to the left in the figure. Licensed under CC BY 4.0.

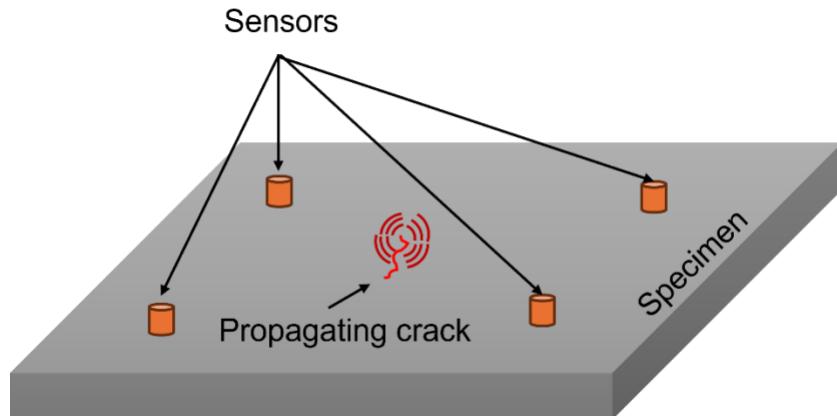
Figure 13. Crack propagation triggers the release of stress waves – acoustic emission.

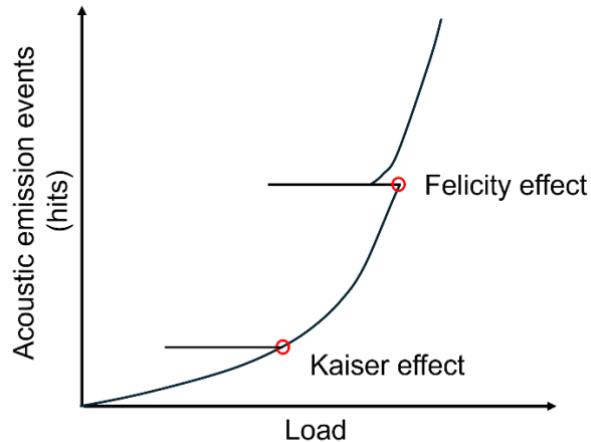
Figure 14. Illustration of the Kaiser and Felicity effects in acoustic emission.

AE activity is typically only produced when the previously applied maximum stress level is exceeded, a phenomenon known as the Kaiser effect [44]. However, this effect is valid only up to a certain load threshold. Beyond this point, reapplying a load may trigger AE events (hits) at stress levels lower than the previous maximum. This behavior is referred to as the Felicity effect [44]. These effects are illustrated in Figure 14, where the number of AE hits is plotted against the applied load.

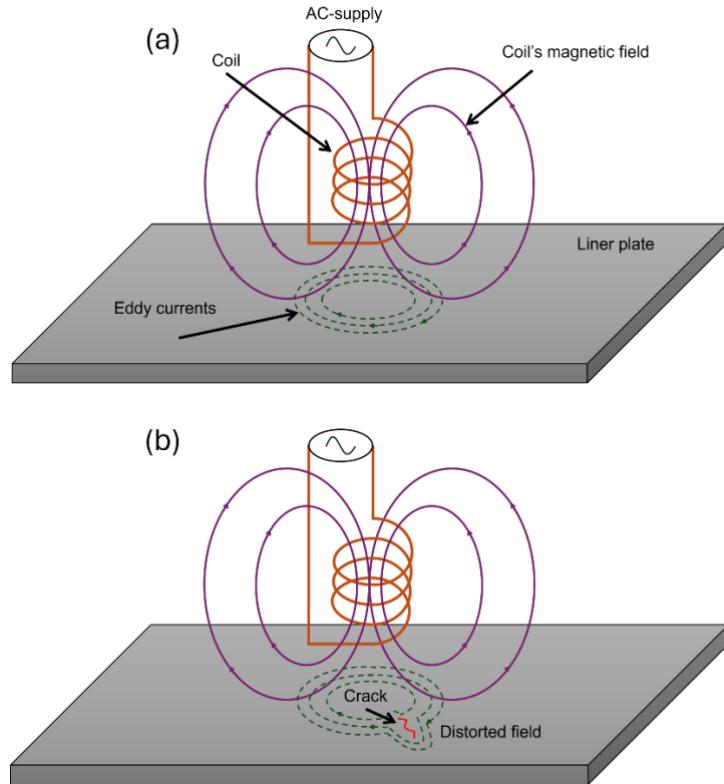
Figure 15. Principle of Eddy Current Testing (ECT). (a) Induction of eddy currents in a defect-free conductive material. (b) Distortion of eddy current flow caused by a surface-breaking crack.

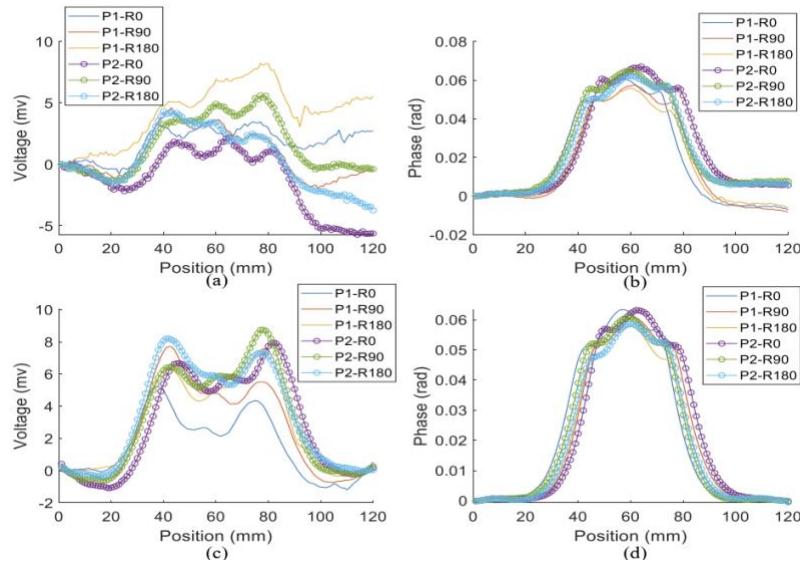
Figure 16. Eddy current response signals showing the effect of lift-off correction. Plots (a) and (b) show voltage and phase before correction; plots (c) and (d) show the corresponding signals after correction using excitation current normalization. Adapted from Xie et al. [48], licensed under CC BY 4.0.

normalized compensation methods that adjust the response signal based on excitation fluctuations [48], as illustrated in Figure 16.

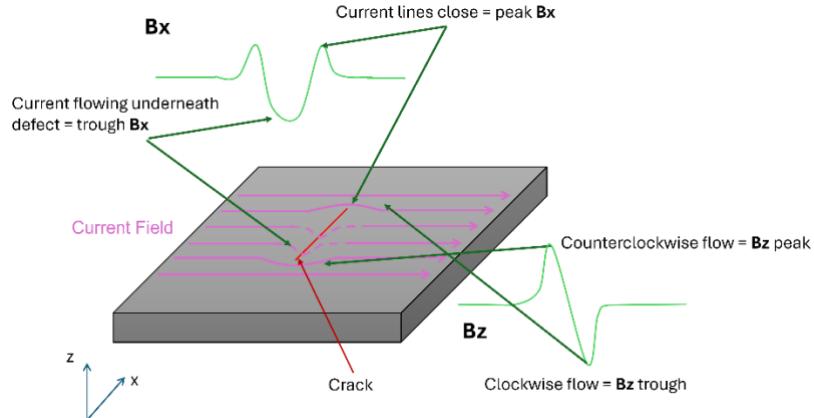
Figure 17. Principle of Alternating Current Field Measurement (ACFM). A surface-breaking crack disturbs the surface current, resulting in characteristic changes in the measured B_x (depth-related) and B_z (length-related) magnetic field components above the surface.

Alternating Current Field Measurement (ACFM) is an electromagnetic NDT technique that enables the detection and sizing of surface-breaking defects in metallic structures. Unlike eddy current testing (ECT), ACFM uses a uniform alternating magnetic field generated by an excitation coil inside the probe. This alternating field induces a controlled surface current in the material beneath the probe, even under water. When a surface-breaking crack is present, the flow of this induced current is perturbed, generating distinctive changes in the local magnetic field. These perturbations are measured using orthogonally placed magnetic sensors, typically referred to as the B_x and B_z channels. The B_x signal primarily relates to crack depth and exhibits a trough due to reduced surface current density above the defect. The B_z signal responds to the redirection of current around the crack tips. A clockwise or counterclockwise deflection results in characteristic peaks and troughs. The separation between these peaks is used to estimate the crack length [53]. The principle of ACFM is illustrated in Figure 17.

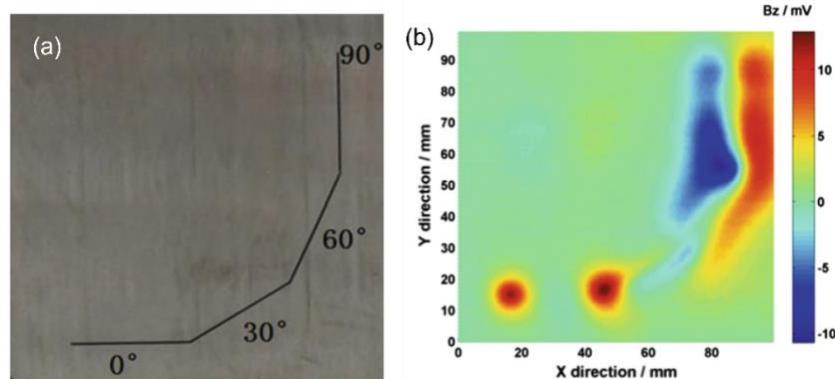
Figure 18. Visualization of irregular crack in austenitic stainless steel using ACFM. Adapted from Yuan X. et al. [61], licensed under CC BY 4.0.

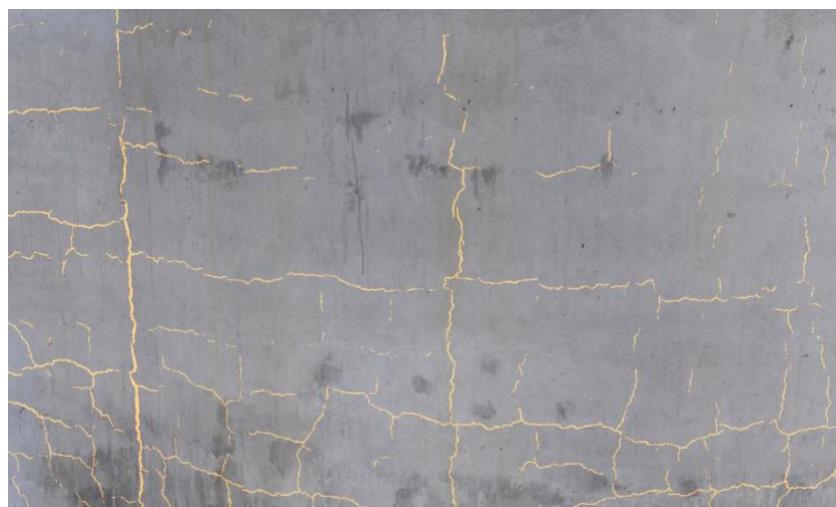
Figure 19. AI-supported high-resolution photogrammetry using drones for remote crack mapping on concrete surfaces. Cracks are highlighted in yellow. Figure from Spotscale.

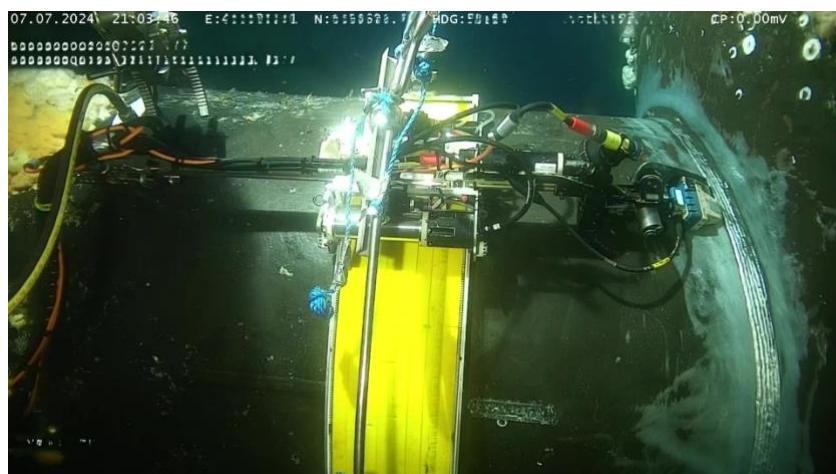
Figure 21. NodeScanner™ performing ACFM weld inspection © TSC Subsea. The ACFM probe can be seen to the right in the figure, near the weld.

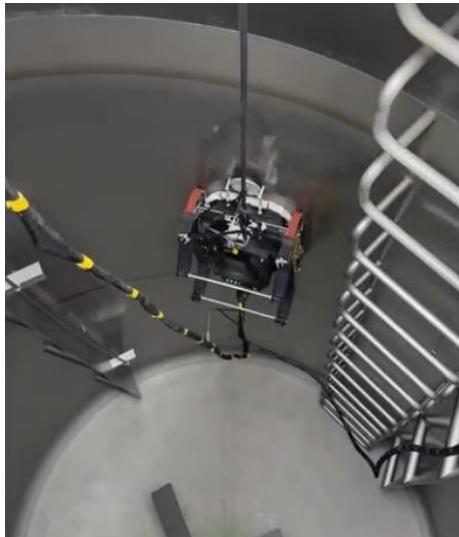
Figure 22. HausBots HB2 deploying UT probe inside a stainless-steel tank. Image courtesy of HausBots Ltd.

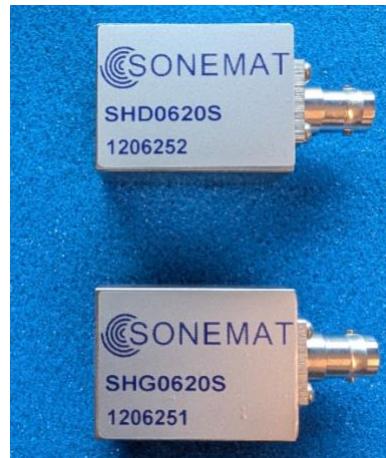
Figure 23. SONEMAT 600 kHz SH-wave probes.

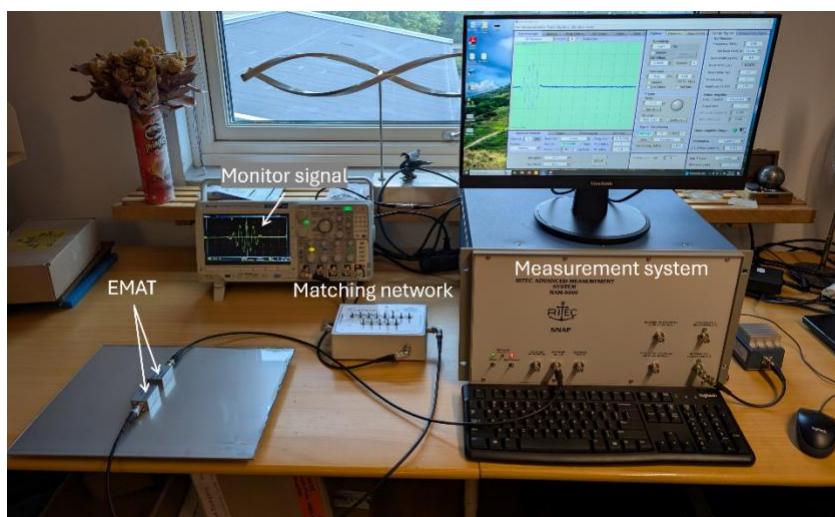
Figure 24. Measurement System for EMAT experiments.

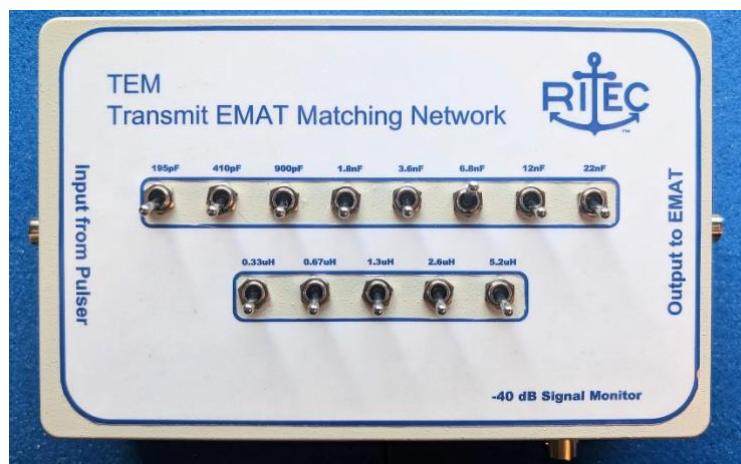
Figure 25. RITEC Transmit EMAT Matching Network.

driver into the EMAT and a cleaner ultrasonic excitation. This setup was deemed optimal as it resulted in the greatest output with minimal ringing.

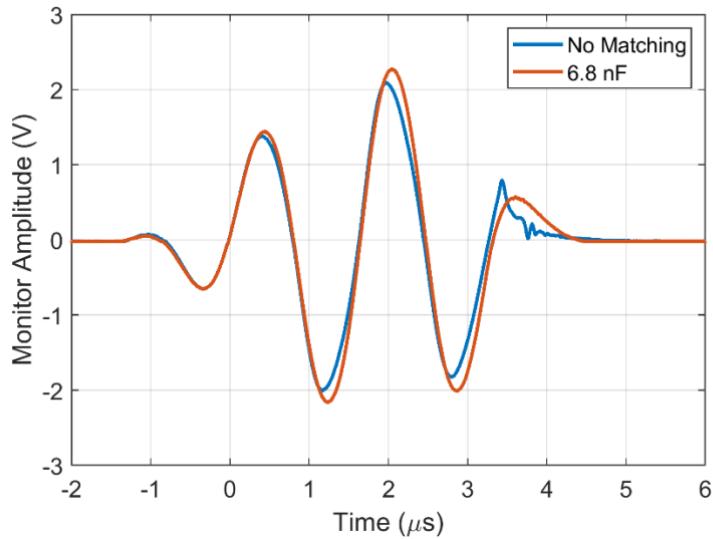
Figure 26. Monitor signals from the EMAT Matching Network with no matching (blue) and 6.8 nF capacitance (orange). Signals are -40 dB with reference to the driving signal.

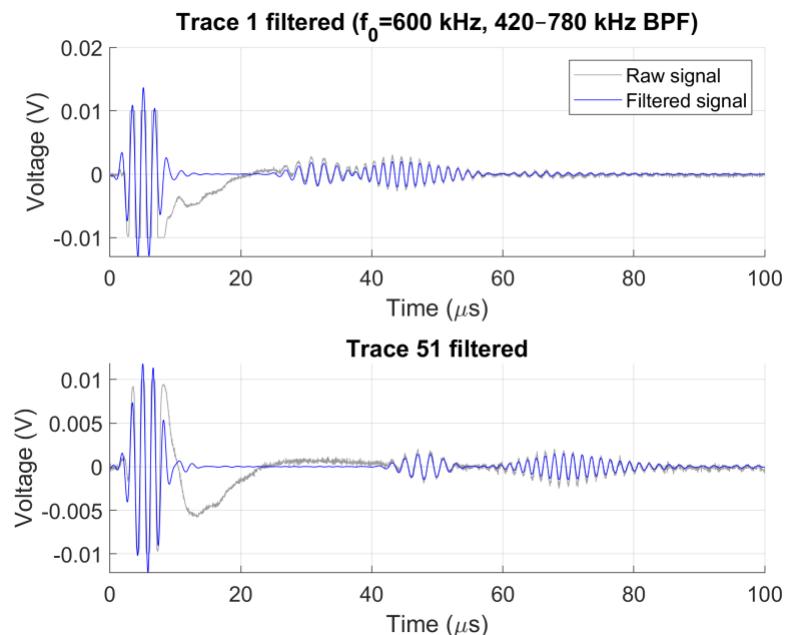
Figure 27. Received EMAT signals at 50 mm (upper plot) and 100 mm (lower plot). The grey curves are the raw signals, and the blue curve are the bandpass filtered signals.

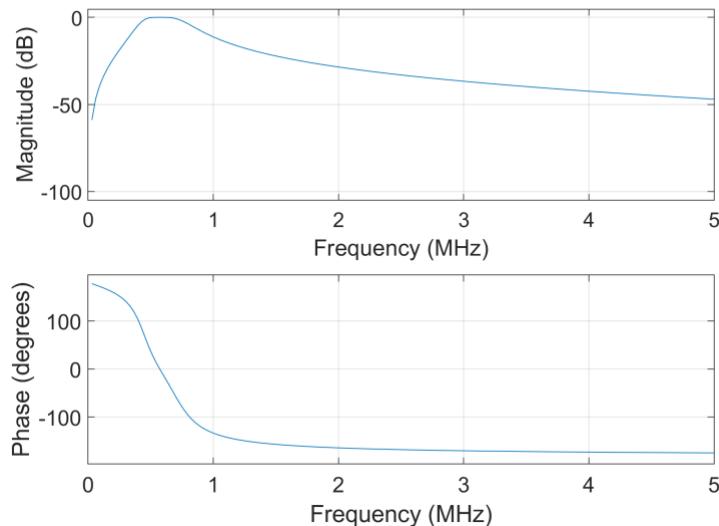
Figure 28. 4th order Butterworth bandpass filter used to improve the clarity of EMAT signals. Passband 420 – 780 kHz.

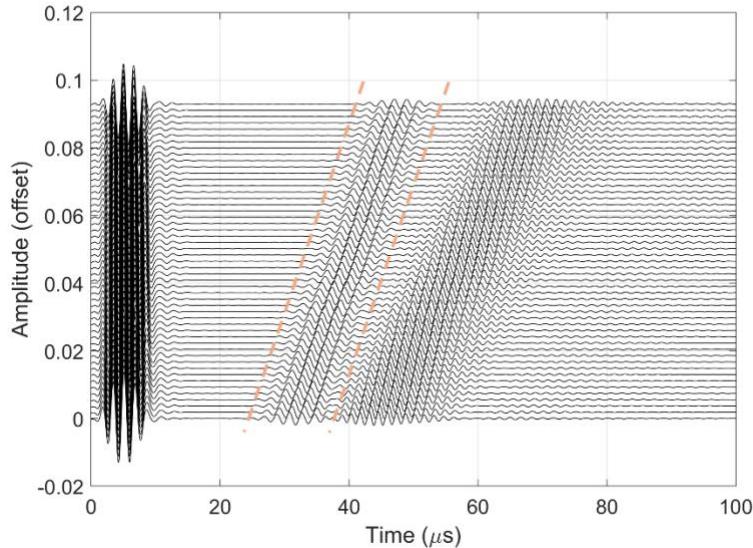
Figure 29. All 51 traces stacked to illustrate a weak drift in arrival time. The bottom trace is for the distance 50 mm, and top is 100 mm. Orange dashed lines highlight the first arrival used for subsequent analysis.

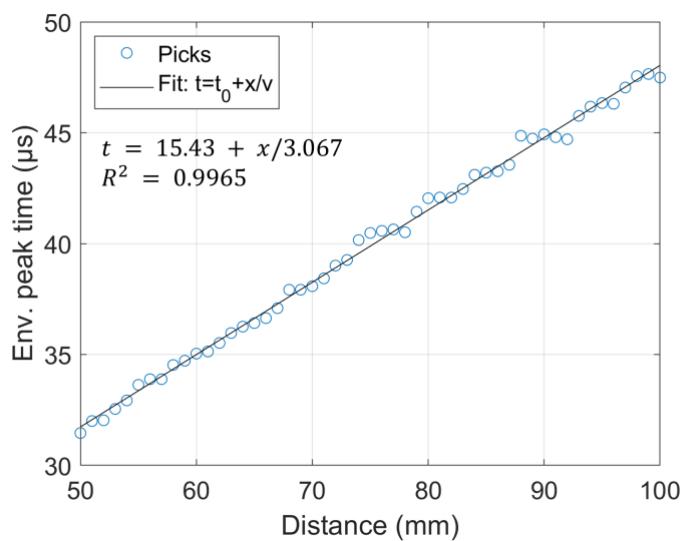
Figure 30. Velocity estimation by peak envelope detection. The estimated shear velocity (3067 m/s) is given by the slope of the line fitted to the time of the peak amplitude for each probing distance.

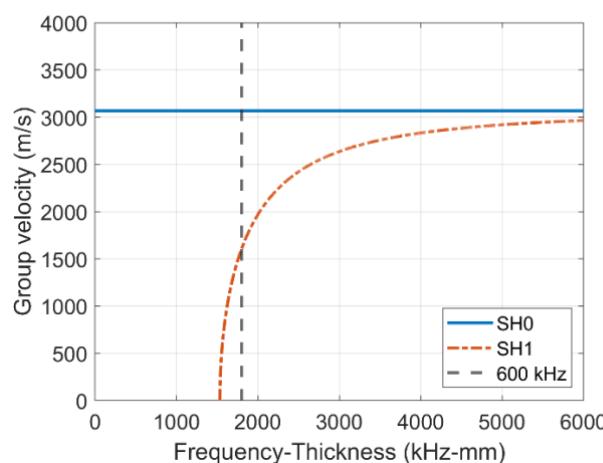
Figure 31. Analytic group velocity curves for the non-dispersive symmetric SH0 mode (blue) and the first dispersive and anti-symmetric mode SH1 (orange dash dotted). Vertical dashed line indicates the frequency-thickness product at 600 kHz and 3 mm.

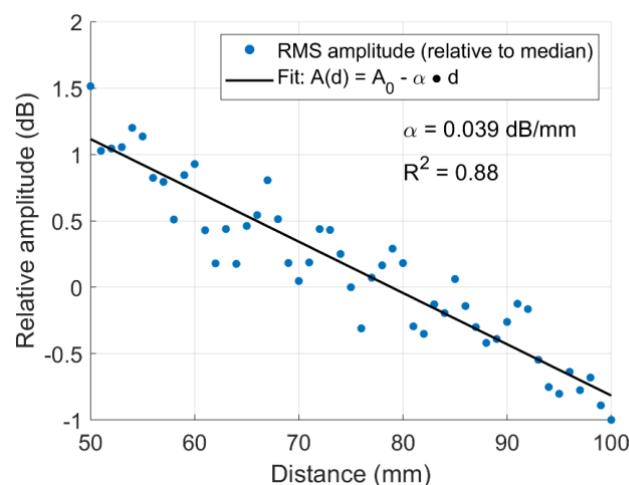
Figure 32. Relative RMS amplitude plotted against distance between probes. The slope of the fitted curve yields an estimate of the attenuation per unit length see eq. (2).

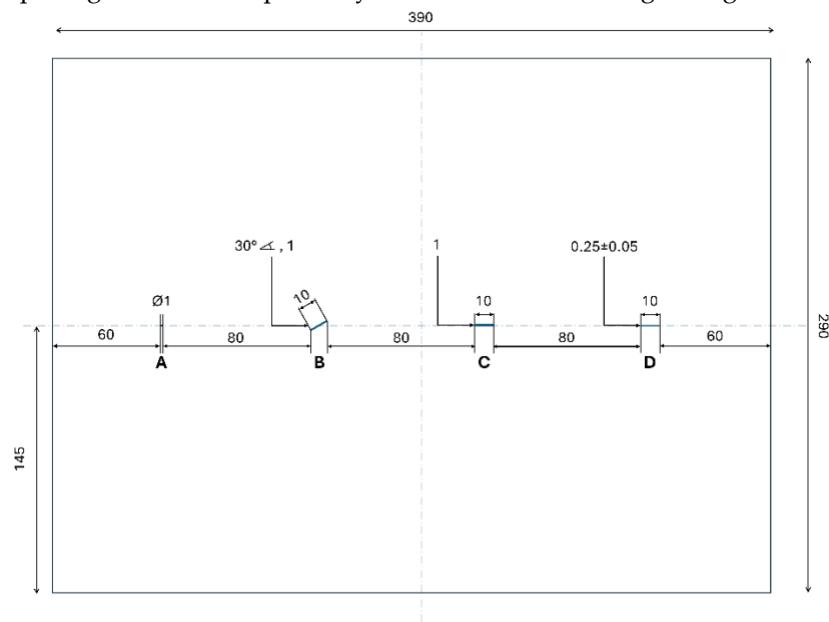
Figure 33. Schematic of the plate specimen. Material: EN 1.4307 (AISI 304L). All defects are through wall. All dimensions are in mm, and the plate was 3 mm thick.

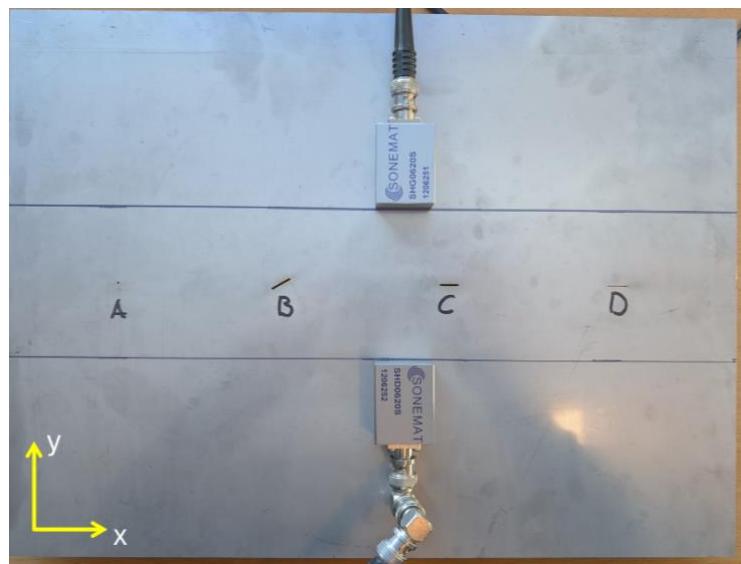
Figure 34. Austenitic steel plate with defects showing sensor placement for the line scan. The upper probe is Tx, lower Rx and the separation between them were 80 mm. Guided SH wave propagation in y-direction and particle displacement in x.

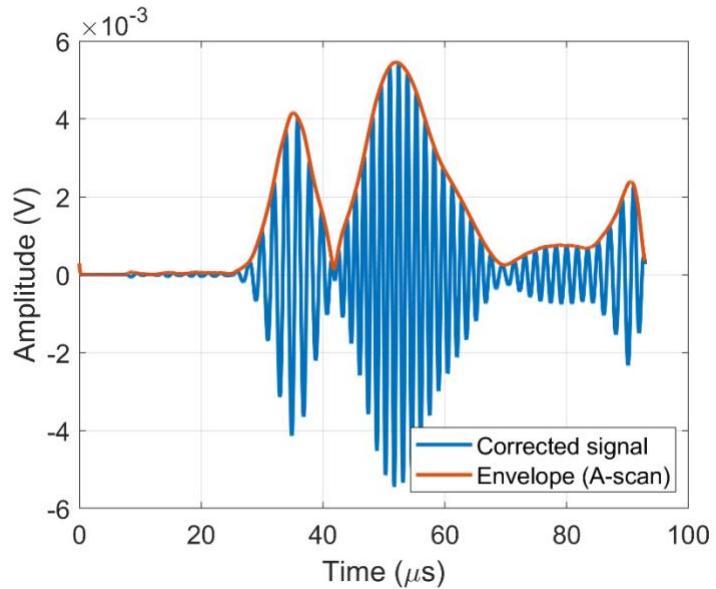
Figure 35. Processed signal (blue) and its envelope (orange) which forms an A-scan.

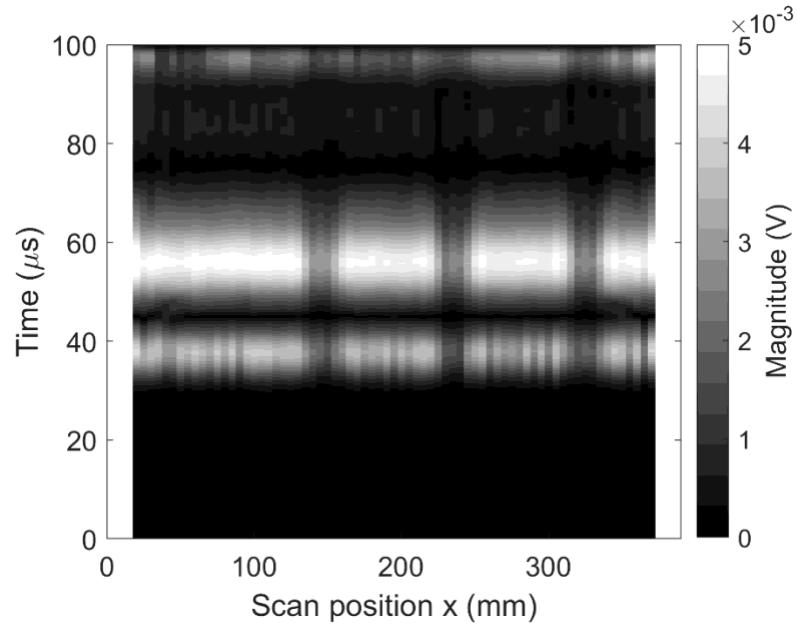
Figure 36. B-Scan from filtered signals.

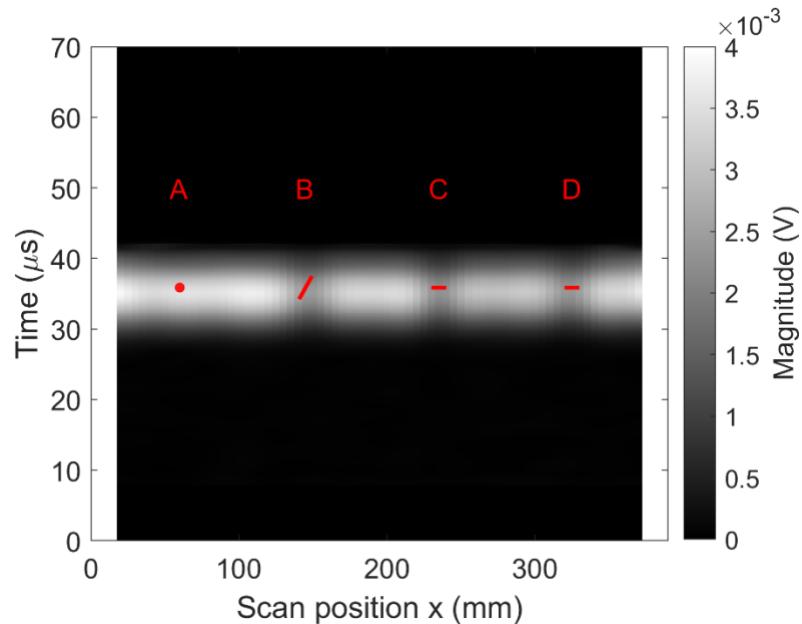
Figure 37. SH0-gated B-scan smoothed using 2-D Gaussian filtering. Defects annotated in red.

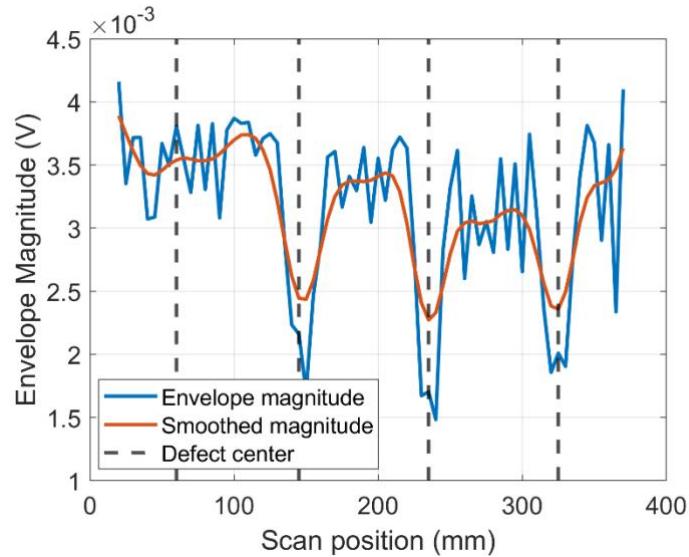
Figure 38. Maximum envelope magnitude for SH0 using filtered (blue) and smoothed (orange) signal. Dashed lines indicate the center position of the defects.

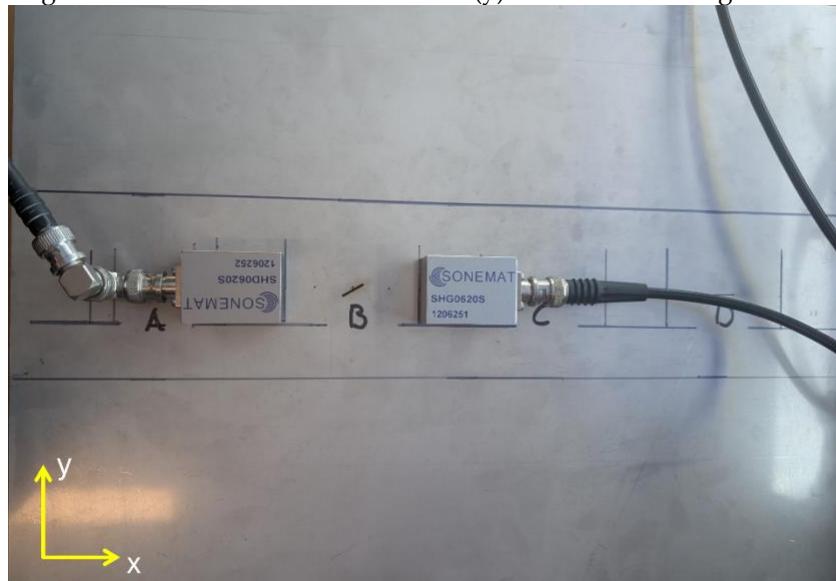
Figure 39. Rotated scan between defects. Guided SH wave propagation in x and particle displacement in y.

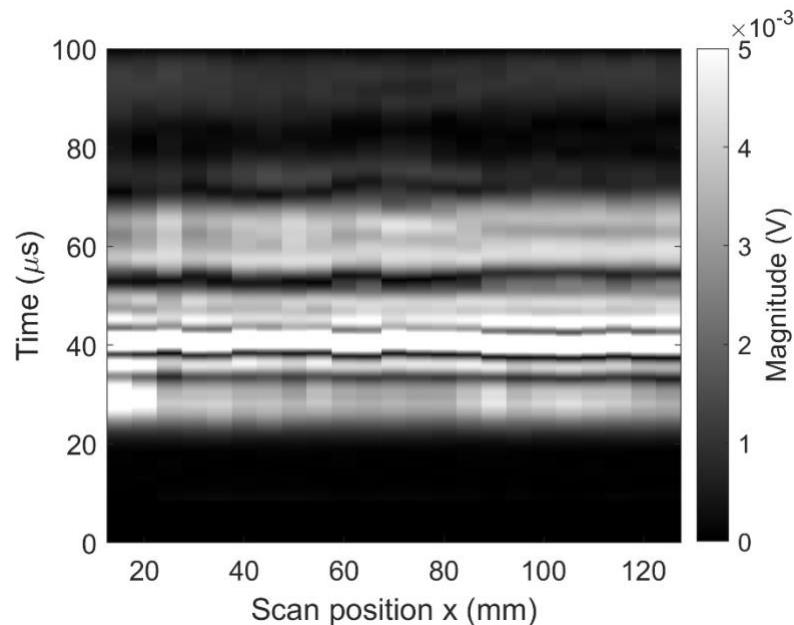
Figure 40. B-scan across defect A. Defect center is at $x = 70$ mm. No indication.

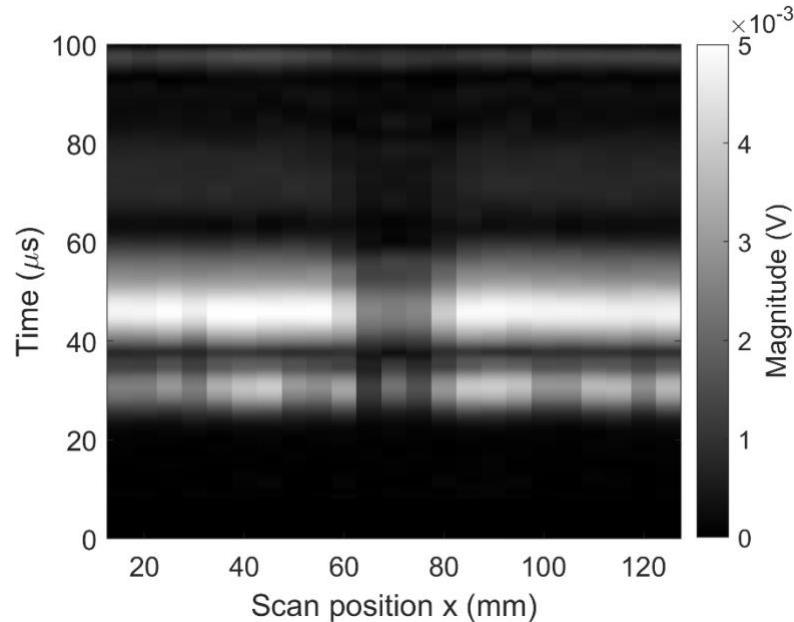
Figure 41. B-scan across defect B. Defect center is at $x = 70$ mm. Clear indication.

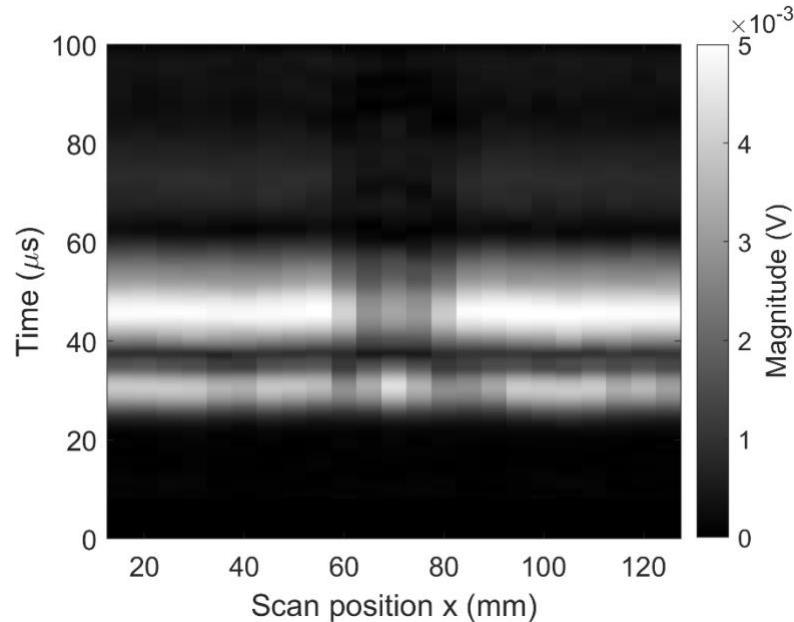
Figure 42. B-scan across defect C. Defect center at $x = 70$ mm. Indication on SH1 wave-packet.

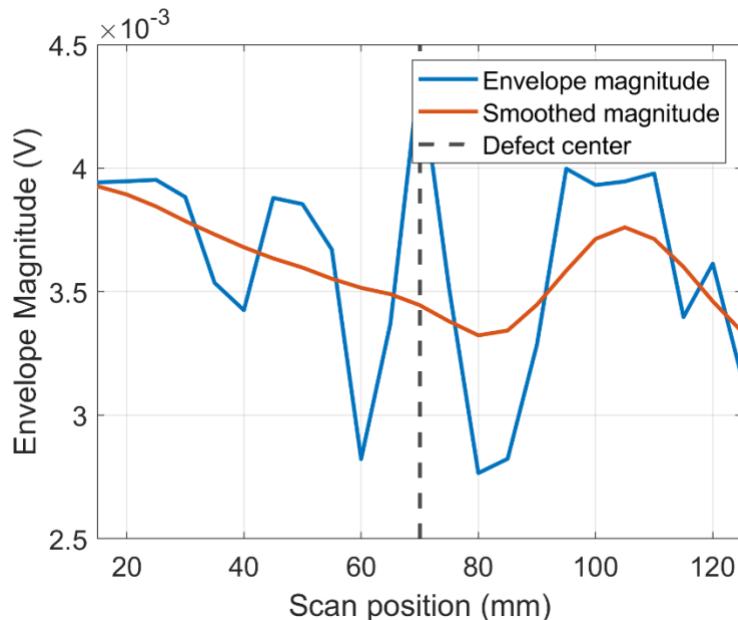
Figure 43. Maximum magnitude for the SH0 wave-packet for defect C.

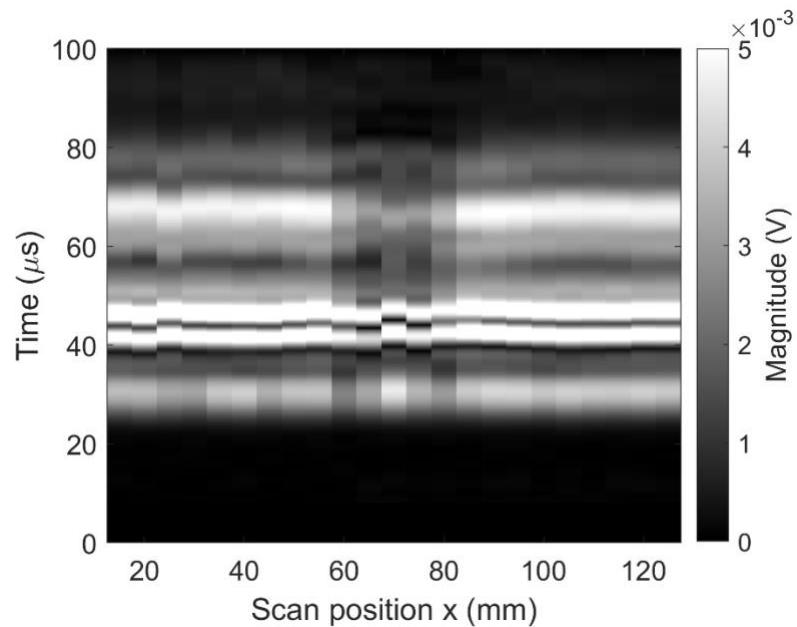
Figure 44. B-scan across defect D. Defect center at $x = 70$ mm. Indication on SH1 wave-packet.

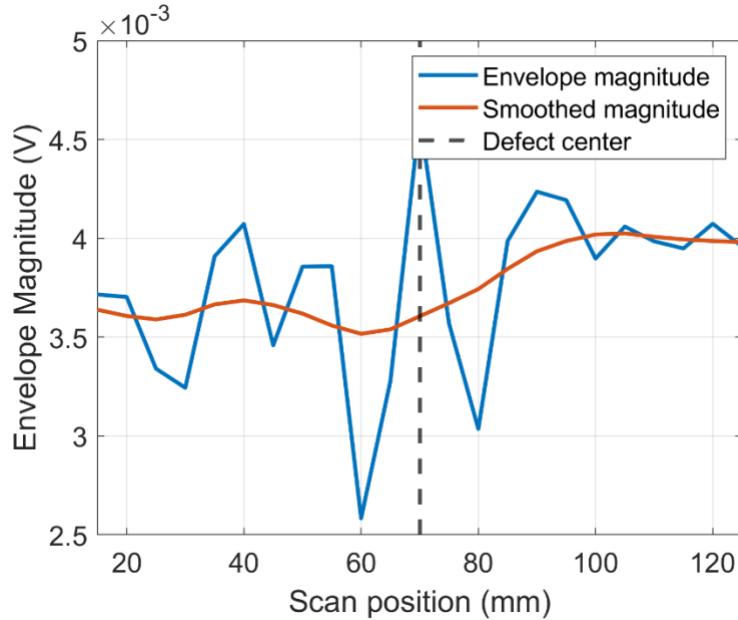
Figure 45. Maximum magnitude of the SH0 wave-packet along the profile for defect D.

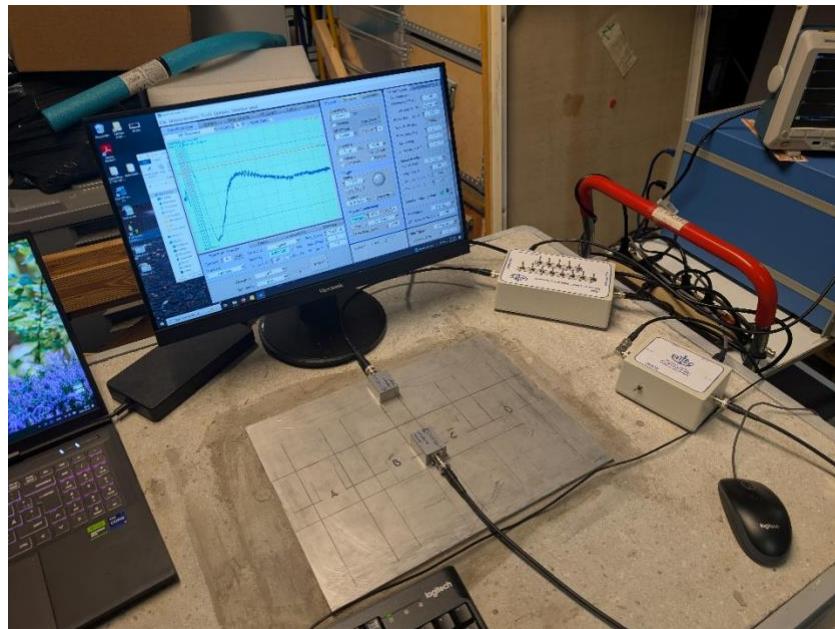
Figure 46. Experimental setup. The plate is attached to the concrete using a cement slurry.

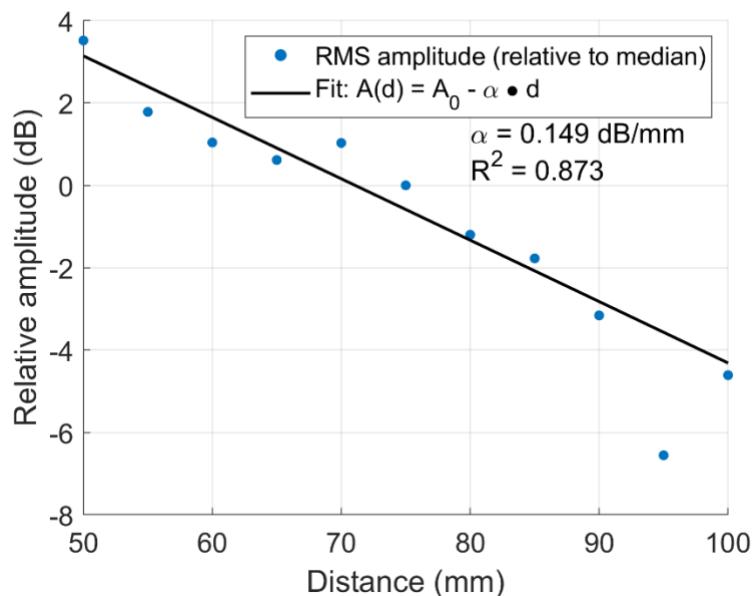
Figure 47. Relative amplitude (in dB) plotted against probe separation. Line fitting gives $\alpha = 0.149 \text{ dB/mm}$ with a coefficient of determination $R^2 = 0.873$.

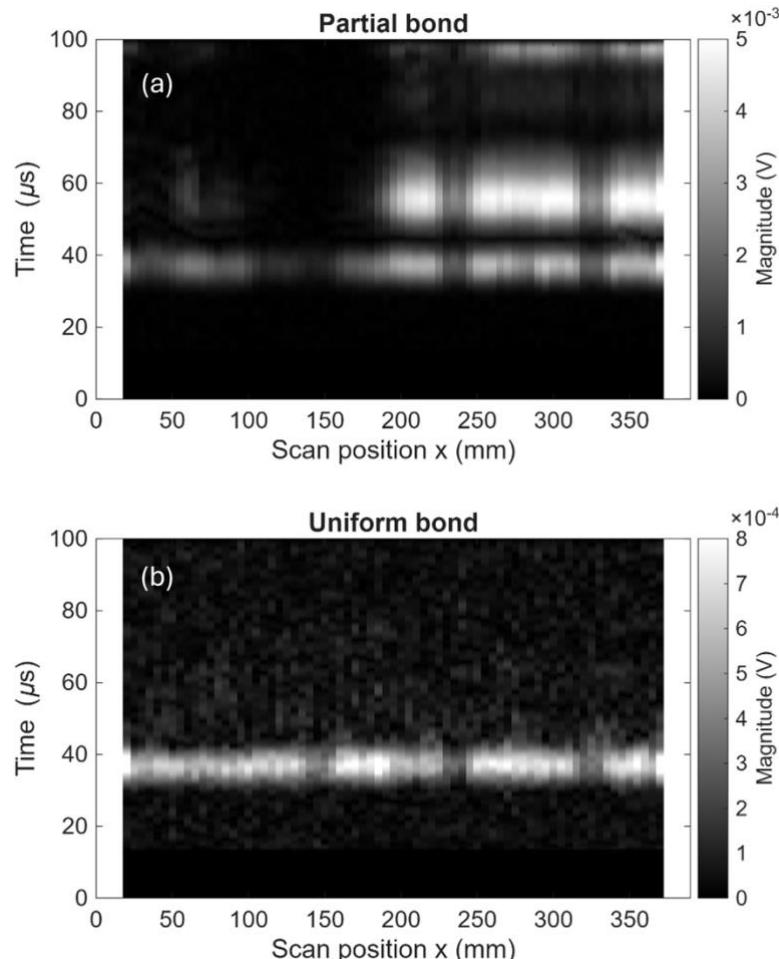
Figure 48. Comparison of transmission measurements obtained for a liner plate bonded to concrete under (a) partially bonded and (b) uniformly bonded conditions. In (a) only part of the plate is mechanically bonded to the concrete substrate, whereas (b) represents uniform bonding over the entire plate area. For the uniformly bonded case, a single SH0 wave packet is observed, while later wave packets present for the free plate are absent due to the changed boundary conditions.

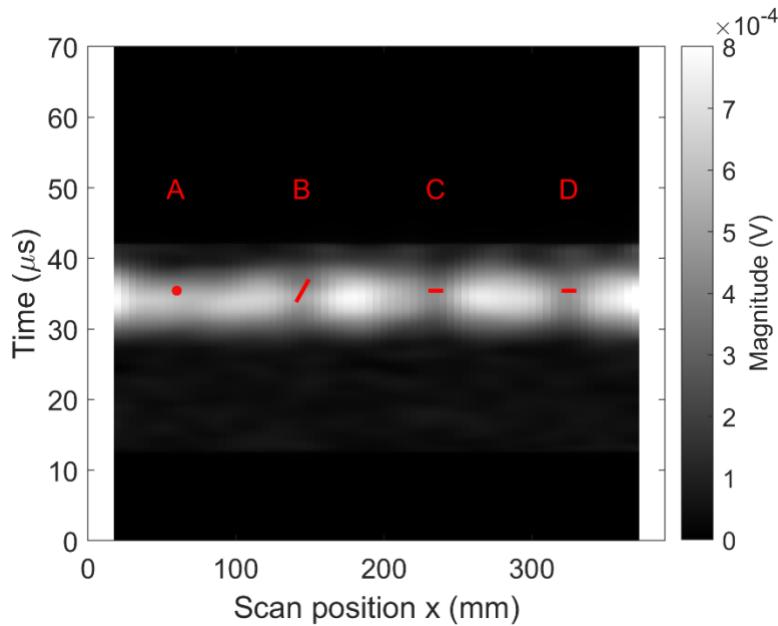
Figure 49. Smoothed B-scan focused on the first arrival. Defects annotated in red.
