METHODS FOR LOCATING POOL LINER LEAKAGE AT NUCLEAR POWER PLANTS

REPORT 2026:1156

**A Review and Experimental Evaluation of Inspection
Techniques for Underwater and Robotic Deployment**

MARKUS NILSSON

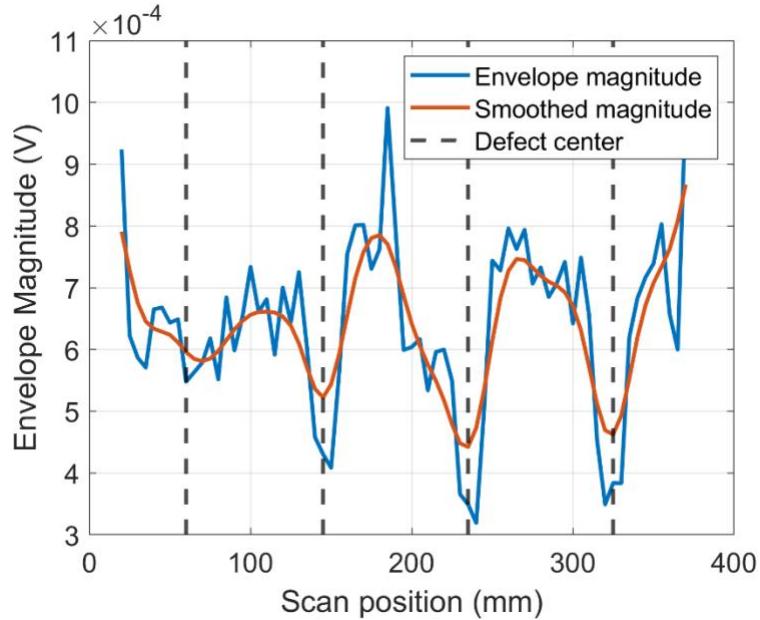
Figure 50. Maximum magnitude along the B-scan profile showing minima at B–D.

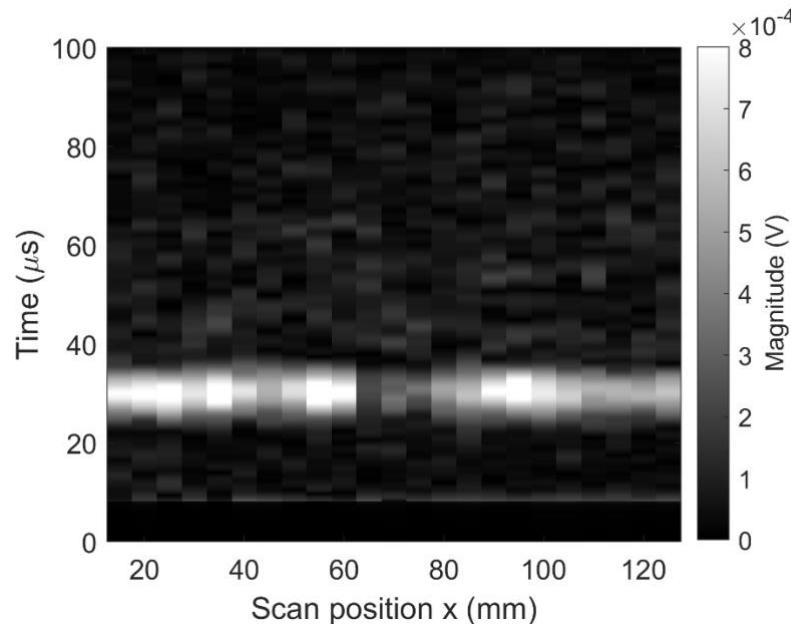
Figure 51. Transmission B-scan for rotated measurements. Defect B is clearly indicated at $x = 70$ mm.

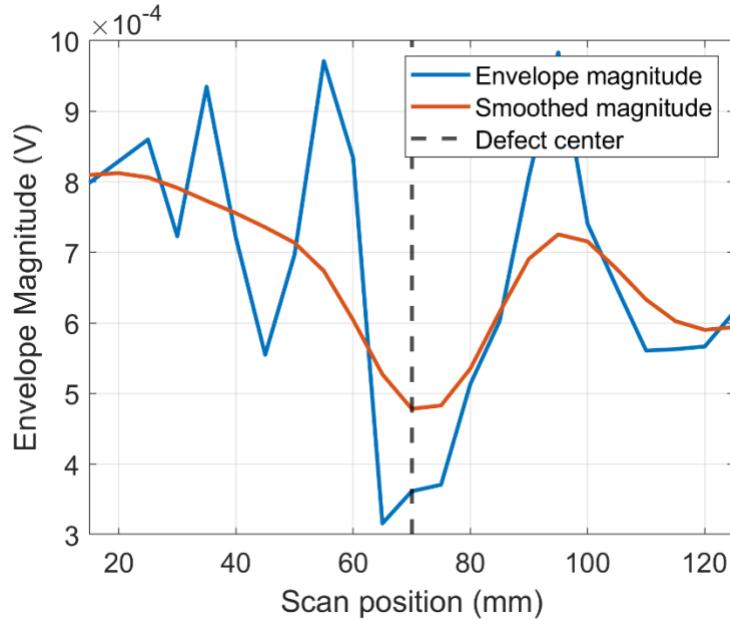
Figure 52. Maximum envelope magnitude for the scan across defect B. Clear indication.

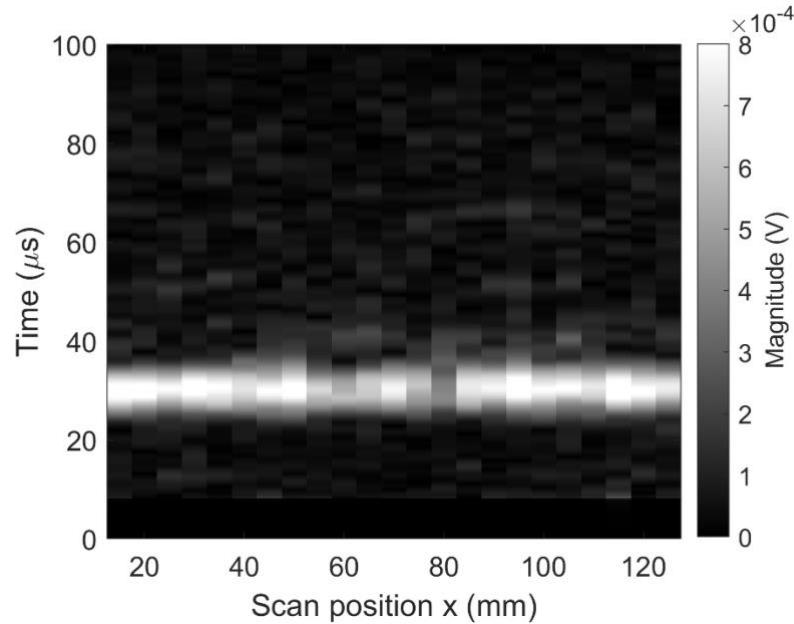
Figure 53. Transmission B-scan for rotated measurements over defect C, no visual indication.

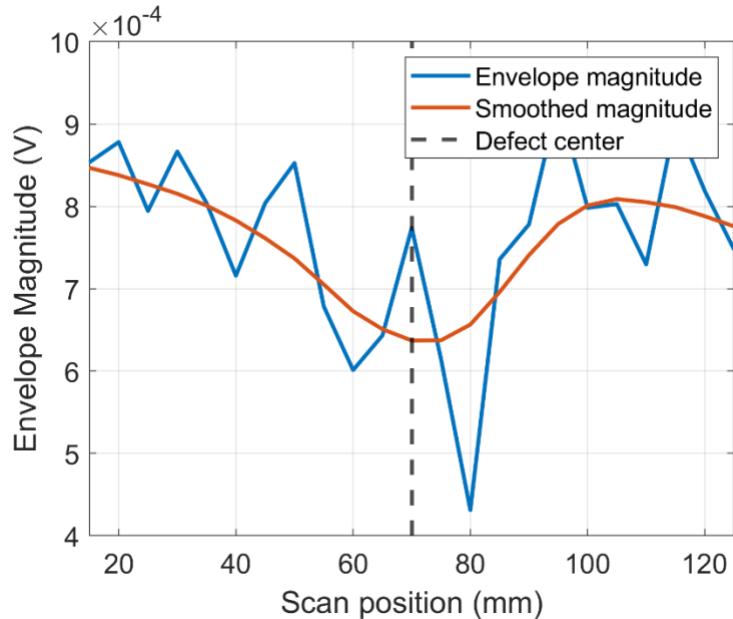
Figure 54. Maximum envelope magnitude for the scan across defect C, weak indication.

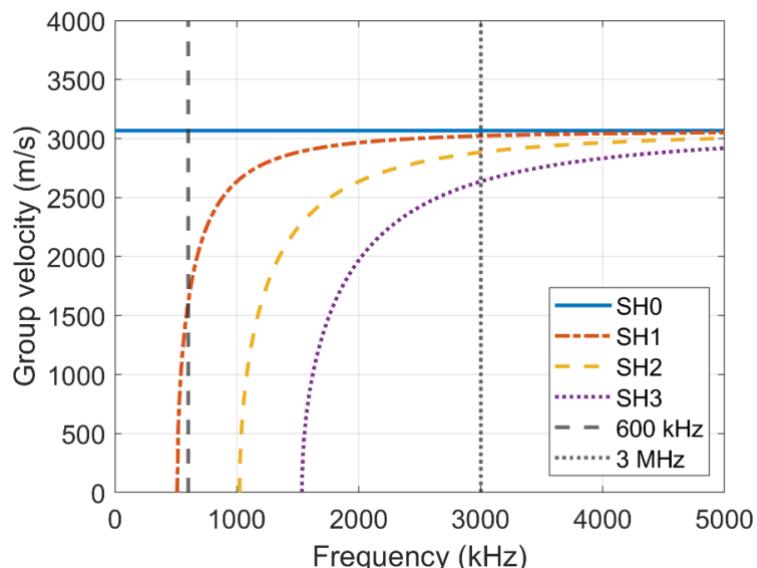
Figure 55. Analytic group velocity (Eq. (3)) for a 3 mm stainless steel plate with up to third-order modes. Frequencies corresponding to 600 kHz (~5mm wavelength) and 3 MHz (~1 mm wavelength) are highlighted with vertical dashed lines.
